**WOOD-BIOLOGICAL INVESTIGATIONS  
ABOUT THE FELLED OAK TREE  
OXENSTIERNSGATAN, STOCKHOLM**

Projekt-Nr. 41-12-01-08

**25th April 2012**

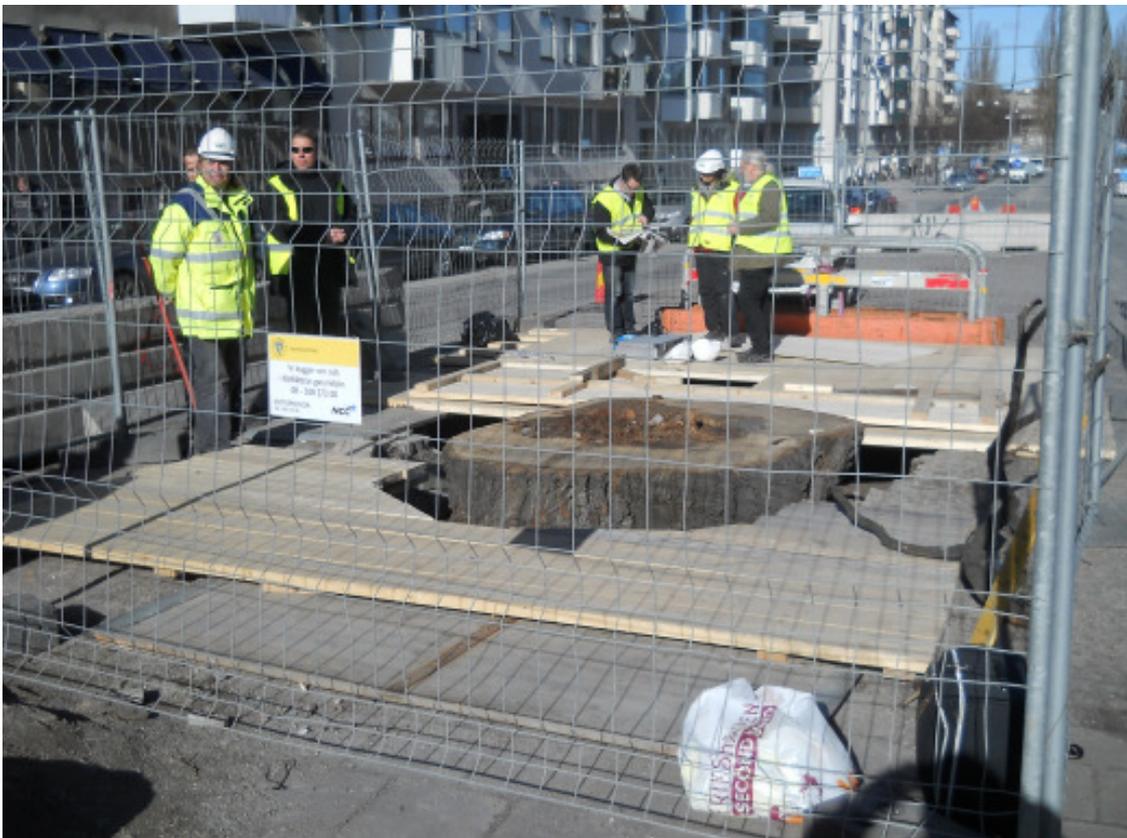
The tree to be examined was an English Oak (*Quercus robur*) located on a small spot of green in the middle of the lanes of a very busy street (pic. 1). It was an extremely disadvantageous location for a tree. During the last decades there had obviously been severe changes in the location around the tree. Excavations on the spot after the felling showed that the tree had been filled in by at least 3 m over the last decades. In the important part of the root zone there was obviously strong soil compaction and the surface was sealed for road construction. These were considerable changes for the location and the oak. Trees in general, even if they are much younger than the oak, are not able to survive such negative changes in the root zone.

Picture 1 The stem base of the oak in Oxenstiernsgatan,  
a very busy street

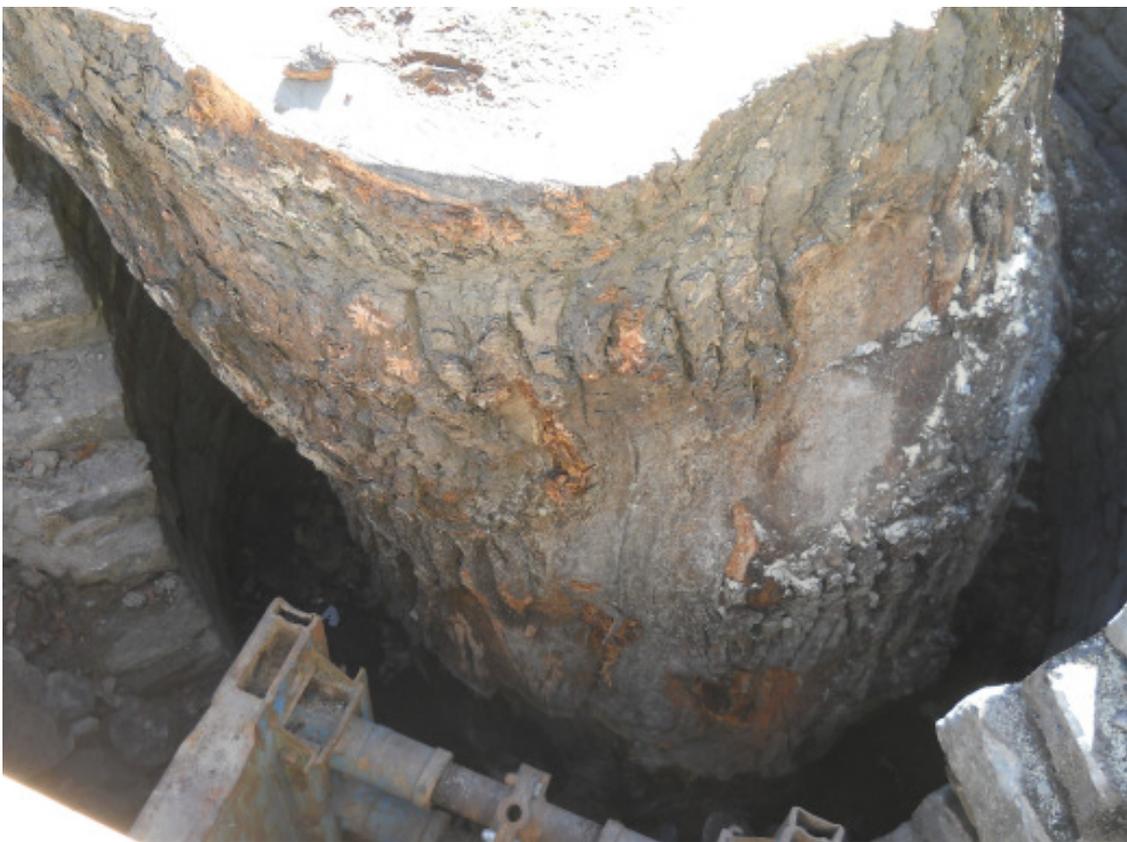
A tree with a poor vitality and few leaves is not necessarily a tree which is not safe anymore. This is the reason why the examination of the wood is important. Having a close look at the stem base and the lower stem in Oxenstiernsgatan showed that the tree had had to suffer a lot of injuries over the last decades (pic. 2). For the examination the lower stem and stem base have been partially exposed. This made obvious that a significant part of the stem base had already been dead (pic. 3).

Picture 2 Many old wounds on the stem base

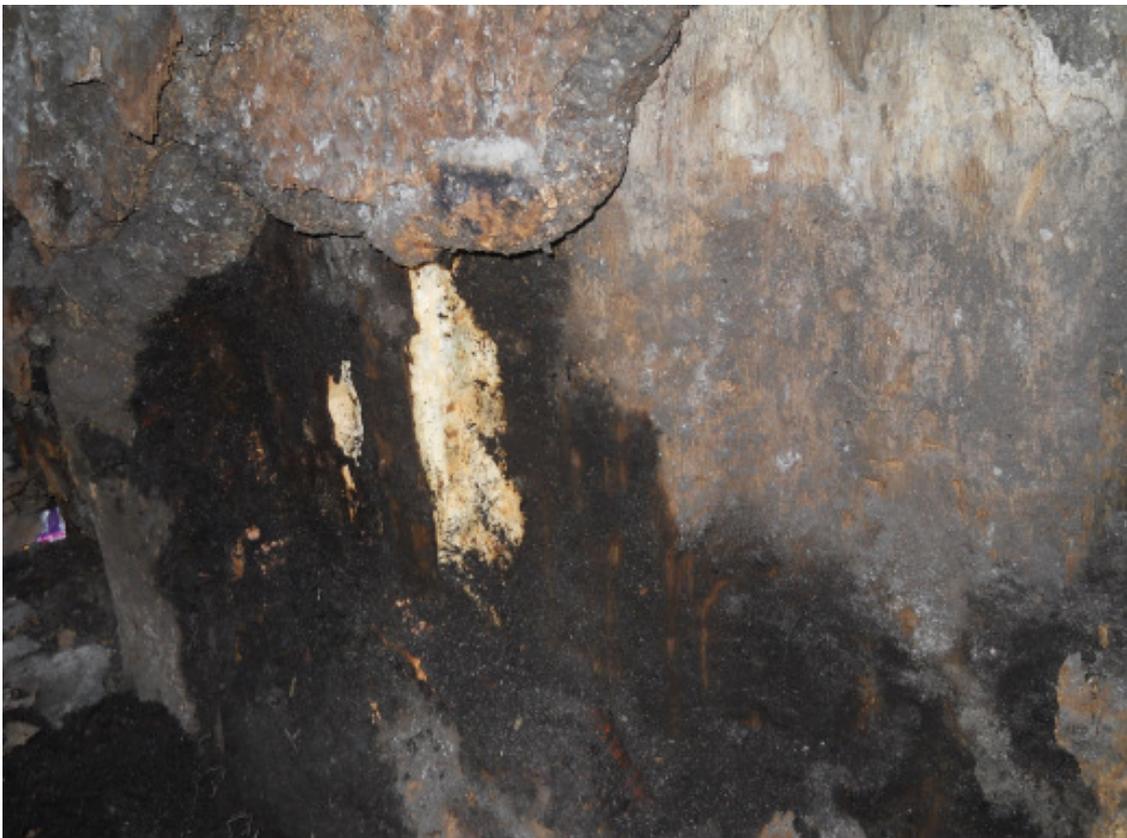
Picture 3 Big old wound with decay at the stem base 3 m deep under the road

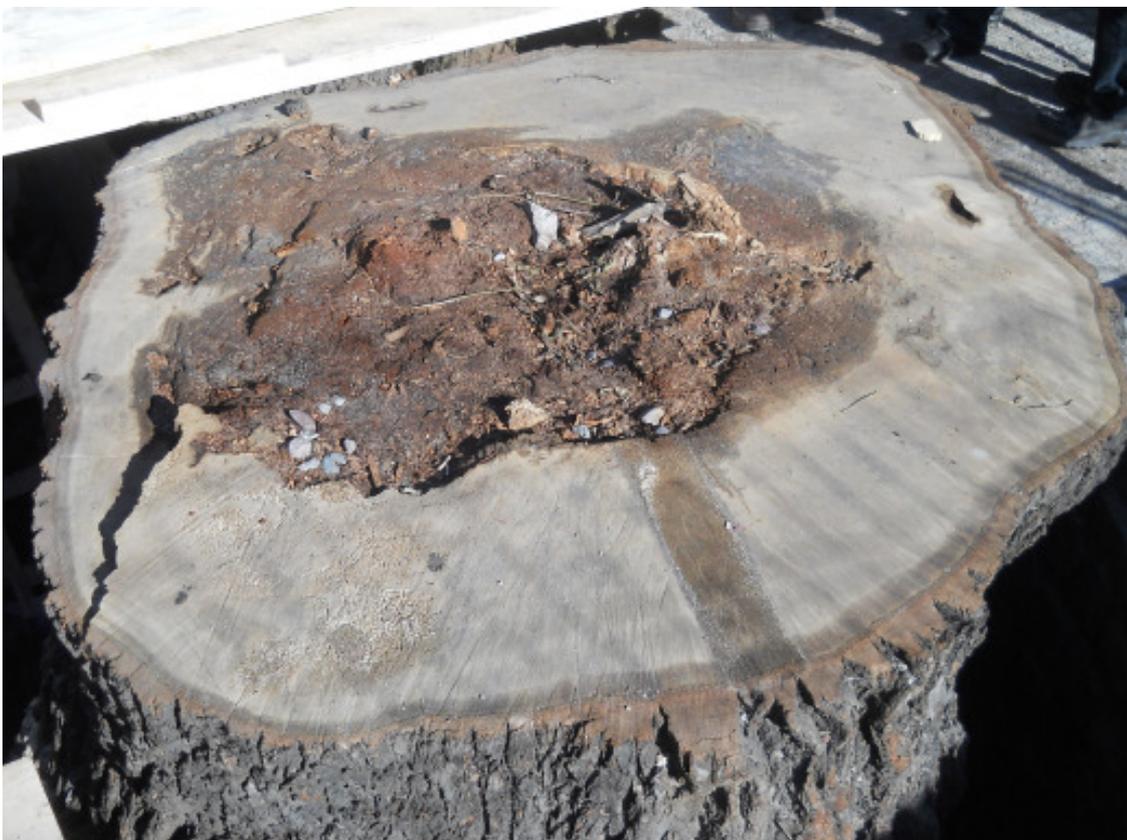
Starting at the various wounds extensive decay has spread inside the stem (pic. 4). It is mainly a brown rot in the heartwood. In the wounded areas also the sapwood was dead and a white rot has been established. The thickness of remaining healthy wood in the stem was in parts less than 10 cm (pic. 5).

Picture 4 Extensive decay (brown rot) in the stem

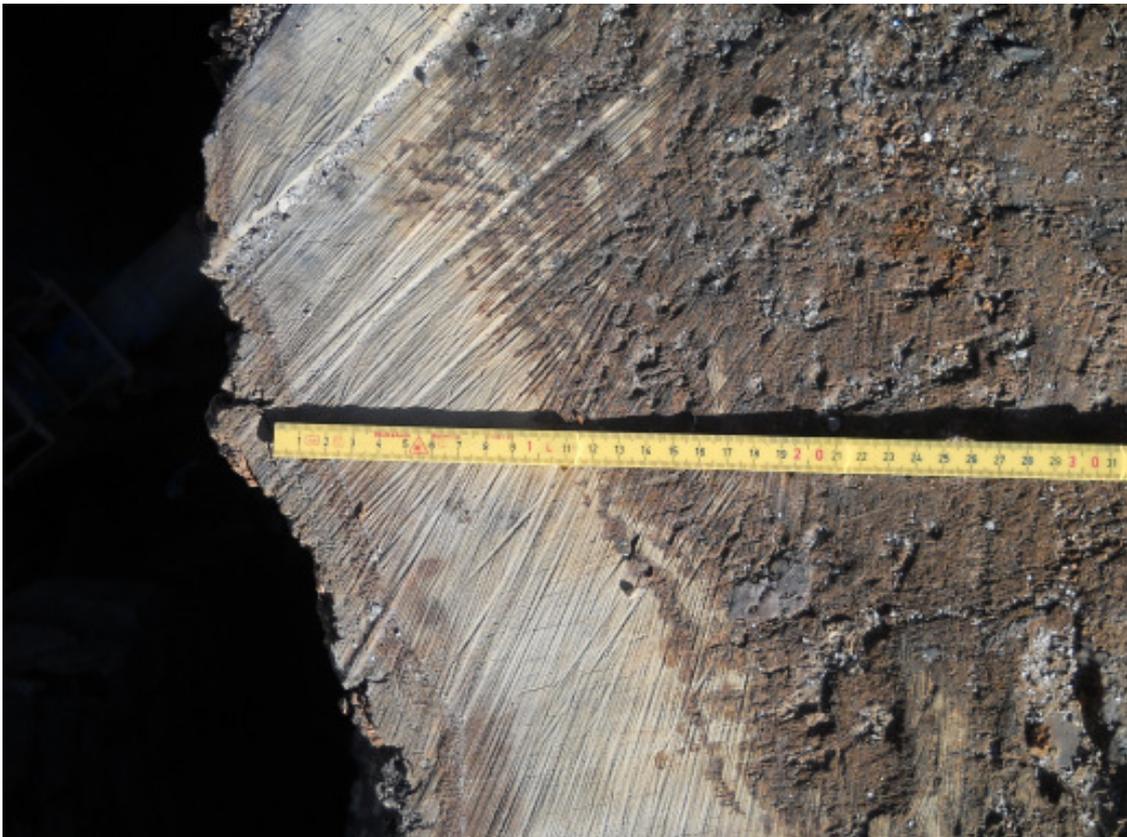
Picture 5 The thickness of sound healthy wood is in parts less than 10 cm

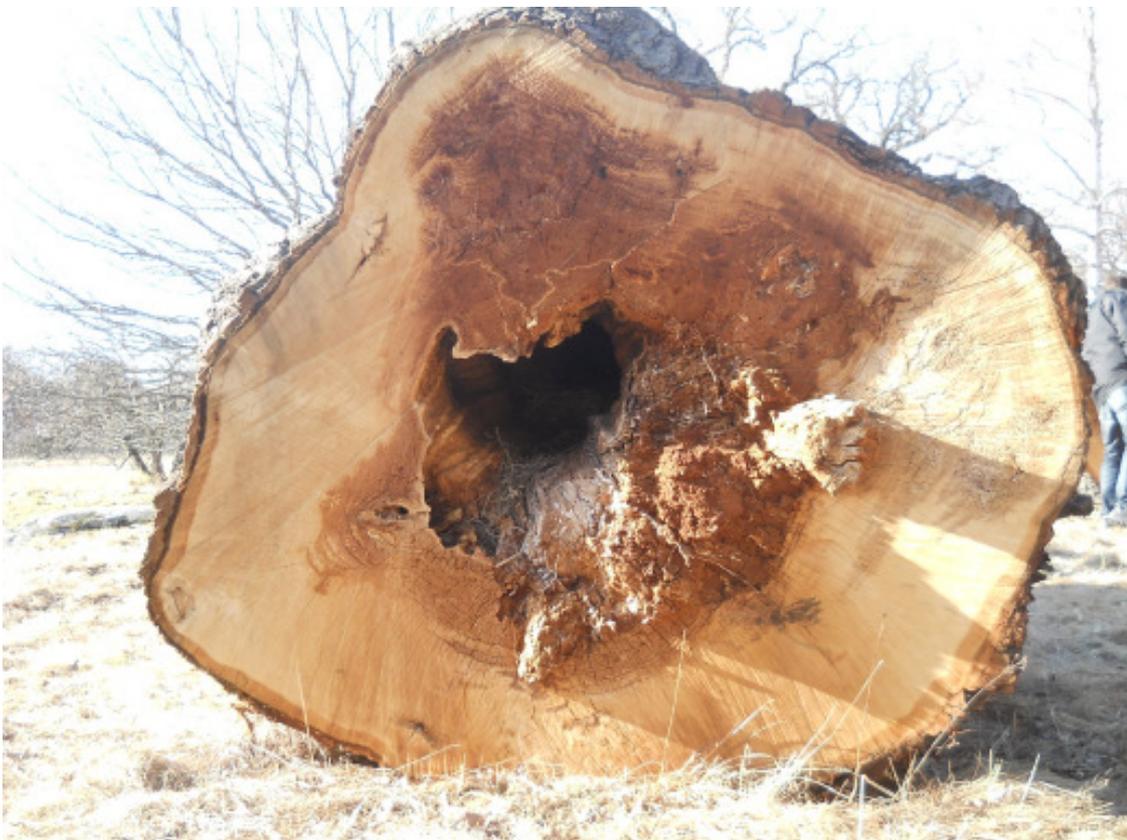
Examination of the stems and branches showed that the oak also showed extensive decay in most parts of the crown (pic. 6 - 12). It was striking that the stem that died in 2011 did not really have noticeable decay (pic. 13) whereas the stems that still had leaves all showed extensive decay. This result also shows that you cannot judge the safety of a tree by its foliage. Even vital branches with a lot of leaves can show severe damages inside.

The damages in parts of the crown are more extensive than in the stem. There were several areas where the bark and the sapwood of the branches of the crown had died back. This means that the remaining thickness of healthy wood was 0 cm. In areas of older wounds in parts even the callus was dead (see pic. 6 – 12).

Picture 6 Decay in the upper stem of the oak

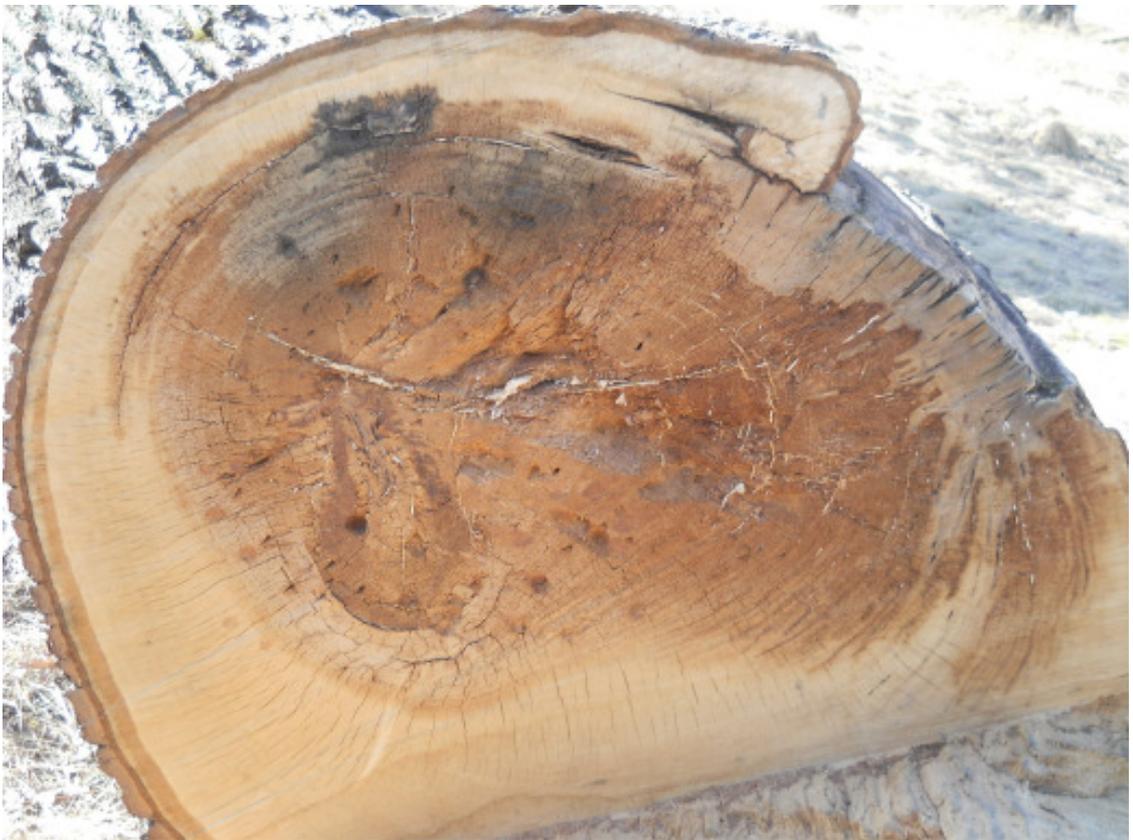
Picture 7 Great amount of decay also in the crown

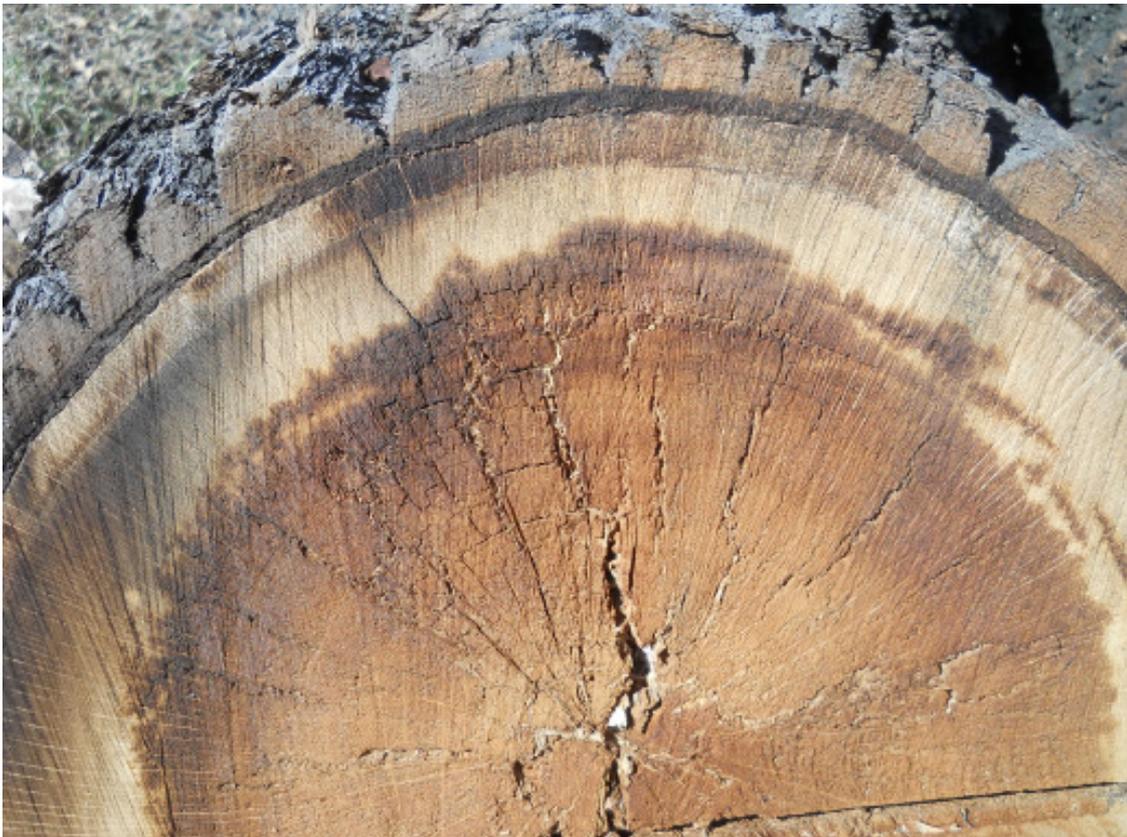
Picture 8 Massive brown rot in another stem in the crown

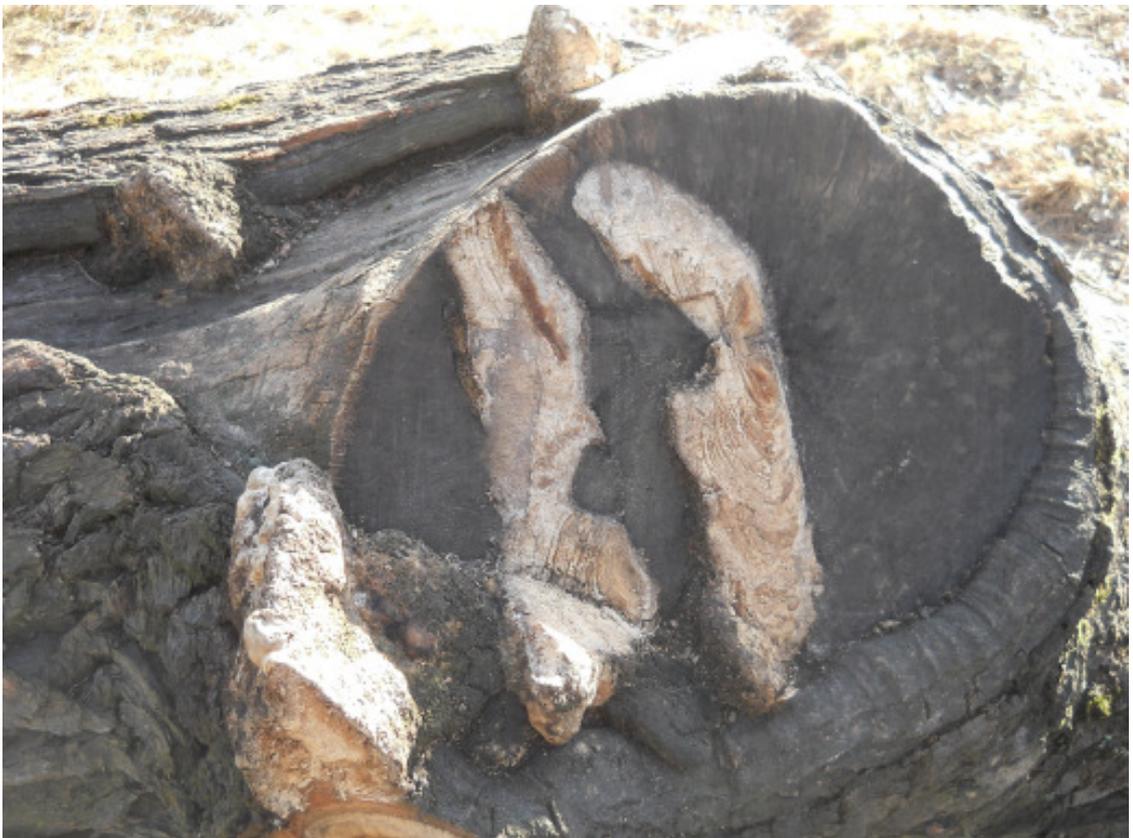
Picture 9 Big wounds and decay in the crown

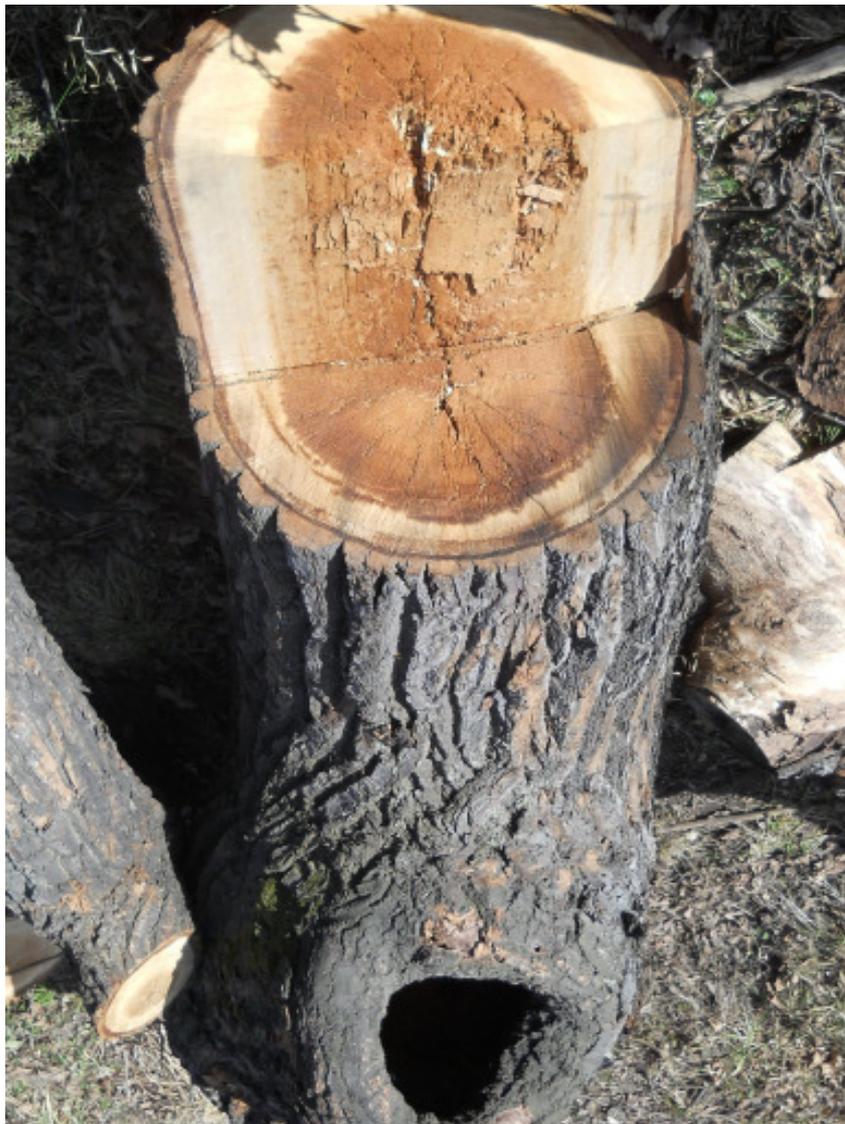
Picture 10 Brown rot in another stem

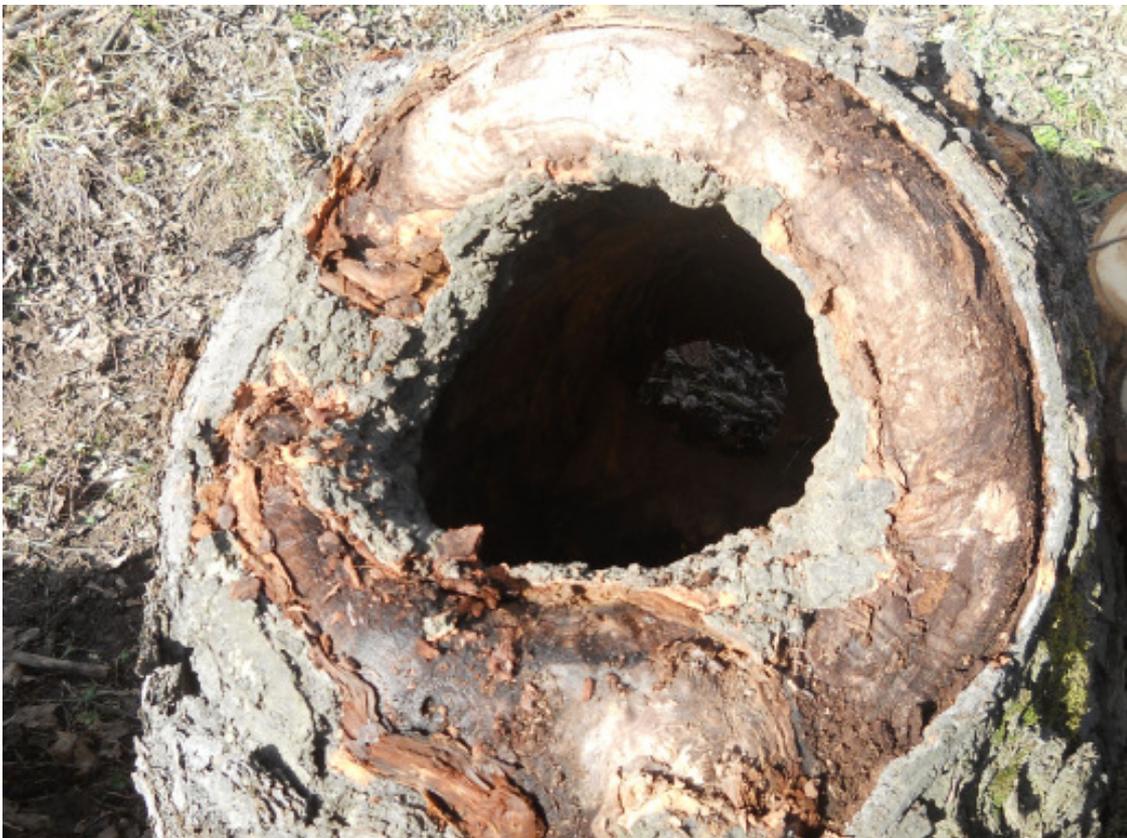
Picture 11 Dead callus of an old wound

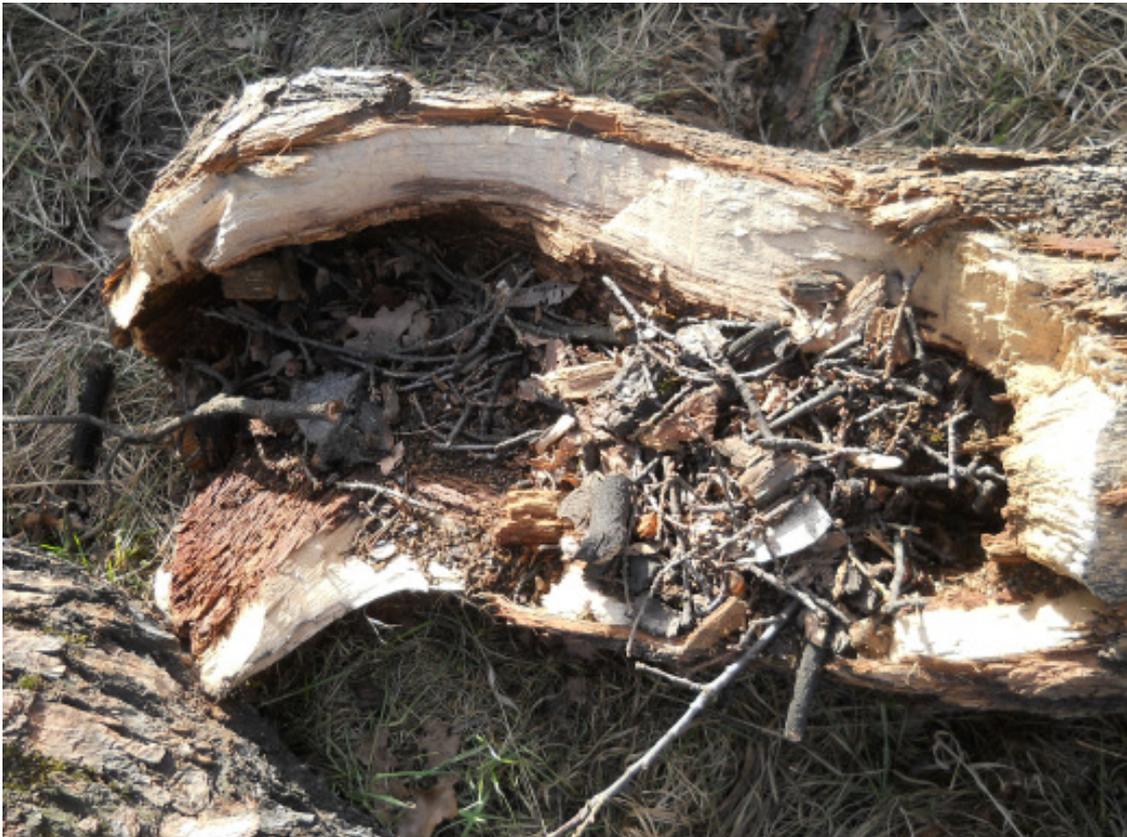
Picture 12 Hollow stem in the upper crown

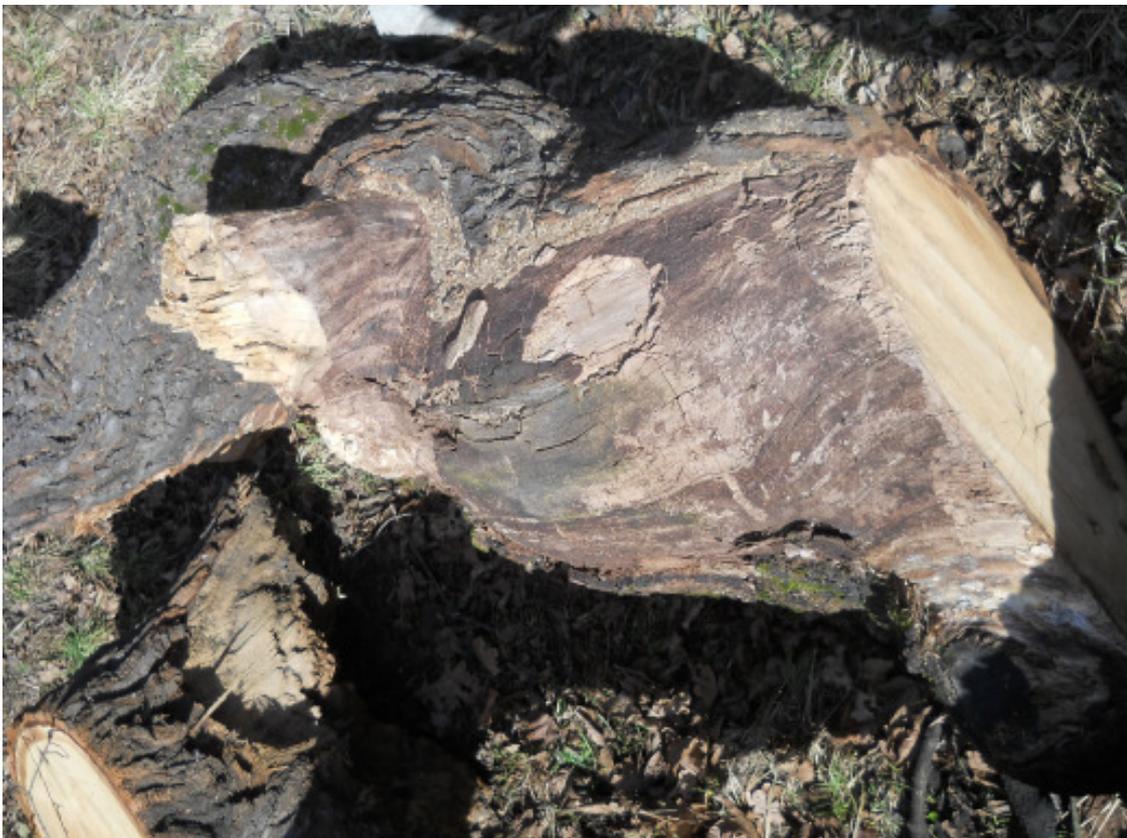
Picture 13 The dead stem without any brown rot inside
