Björn Embrén  
Trafikkontoret  
Stadsmiljö/Park och Stadsmiljö  
Fleminggatan 4  
104 20 Stockholm

Skov & Landskab  
Københavns Universitet  
Rolighedsvej 23  
1958 Frederiksberg C  
Tel. 3533 1500  
SL@life.ku.dk  
www.SL.life.ku.dk

Dato April 20th 2012  
J.nr. 522-002/  
Ref. IMT  
E-post imt@life.ku.dk  
Tel. dir. 35331664

## Radiohuseken in Stockholm

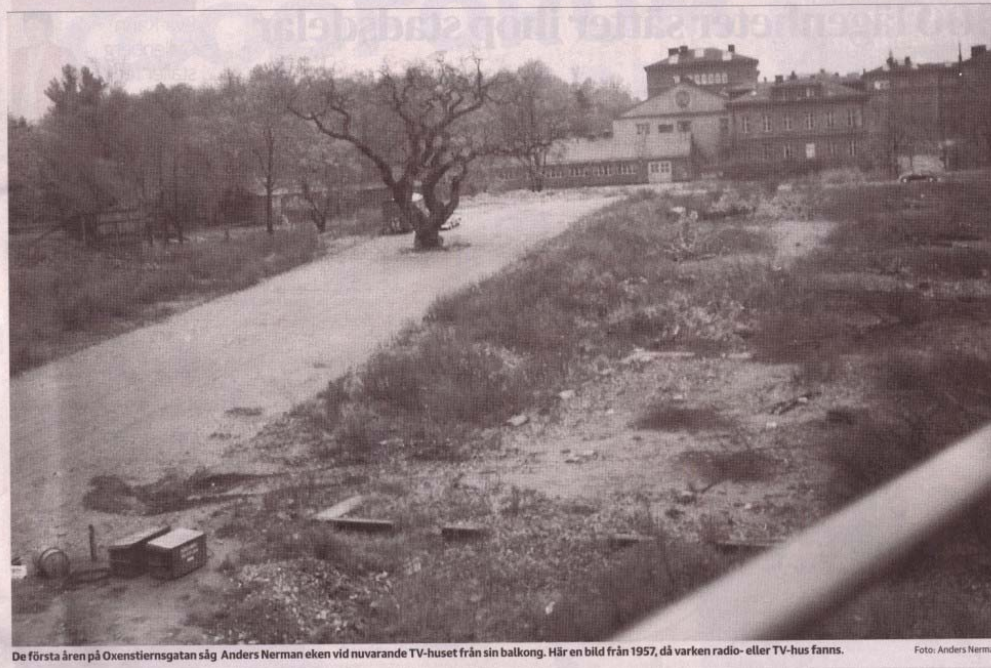
De första åren på Oxenstiernsgatan såg Anders Nerman eken vid nuvarande TV-huset från sin balkong. Här en bild från 1957, då varken radio- eller TV-hus fanns. Foto: Anders Nerman

**1957** It looks like there has already been landfill done around the oak tree, because not much main stem is visible below the division into five large stems / branches. Root damage probably occurred to some extent, depending on the material used and how much compression had been done. Unfortunately nothing is known of the tree health prior to this time.

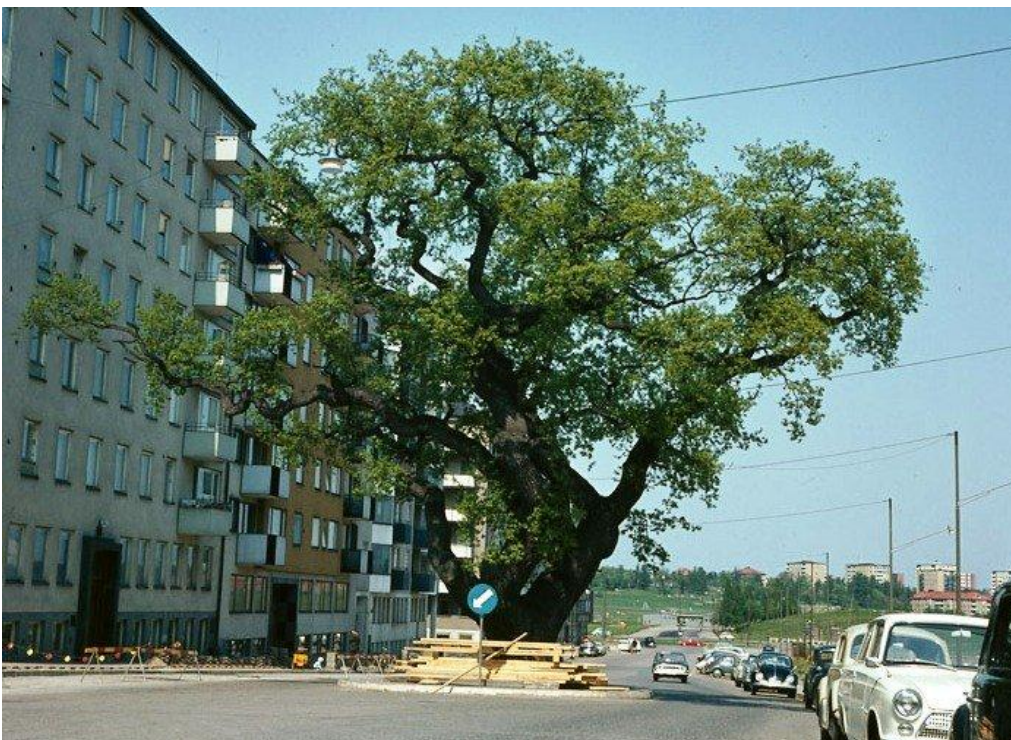
**1963** Road construction seems to be almost finished. The tree crown is already thin, but still acceptable for an old oak. Presumably excavation around the buried tree stem and construction of the well with a wood deck at street level was done at this time. Damage to the main stem was probably from this time.

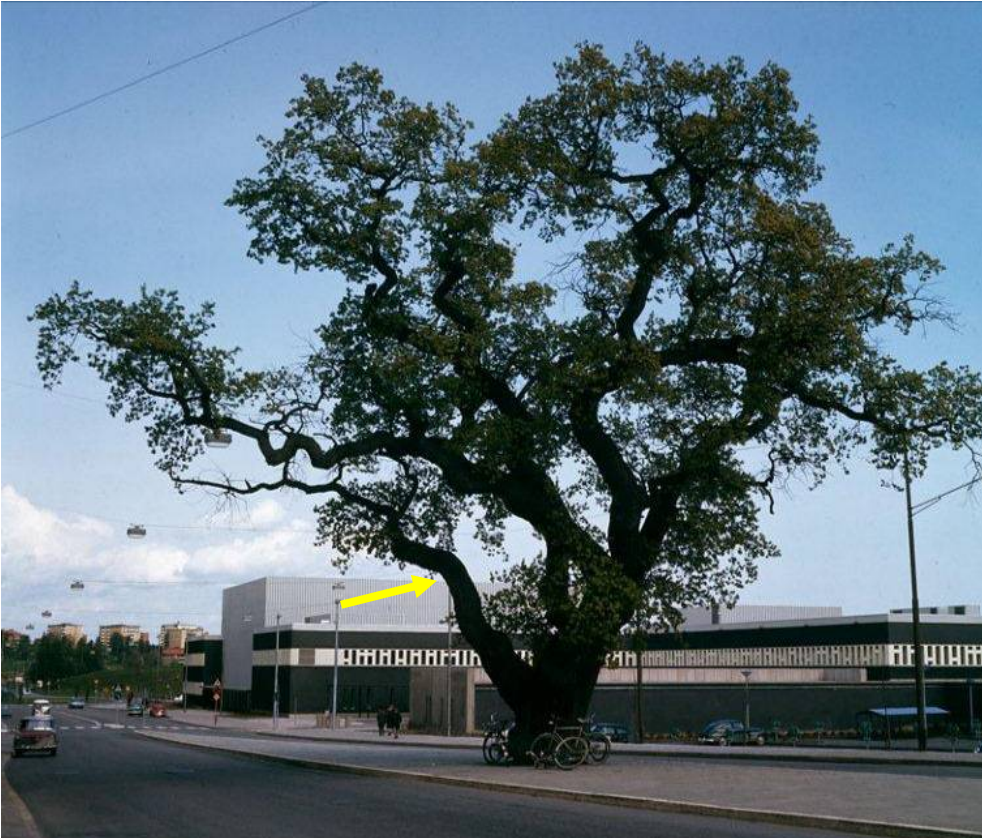
**1968** Dieback of twigs has begun in several places, and the lowest side branch (arrow) is already dying. This branch was removed in the 1970'ies, when dead. The crown is thin, and the symptoms are in accordance with severe water and nutrient deficiency due to root death (uptake and transport problems).

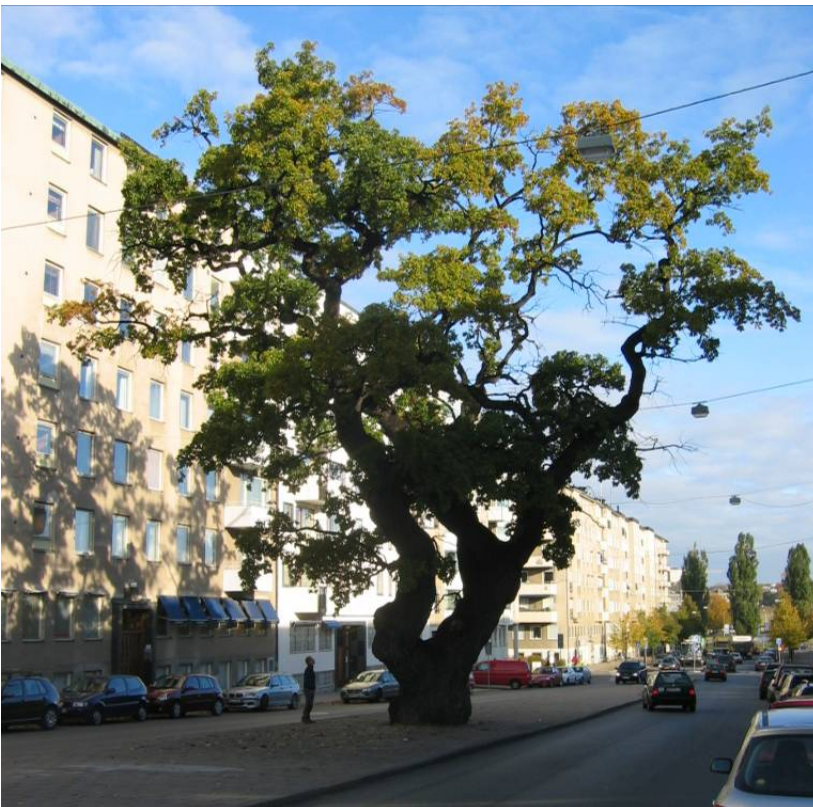
**2003** October: after two dry hot summers in a row (2002 and 2003) crown dieback is even more pronounced, with newly dead twigs. Compare with 1963 to see how the crown has condensed to lumps of foliage. In spite of the continued decline the oak still

has an acceptable crown, considering the damage to roots and stem (below the tree deck).

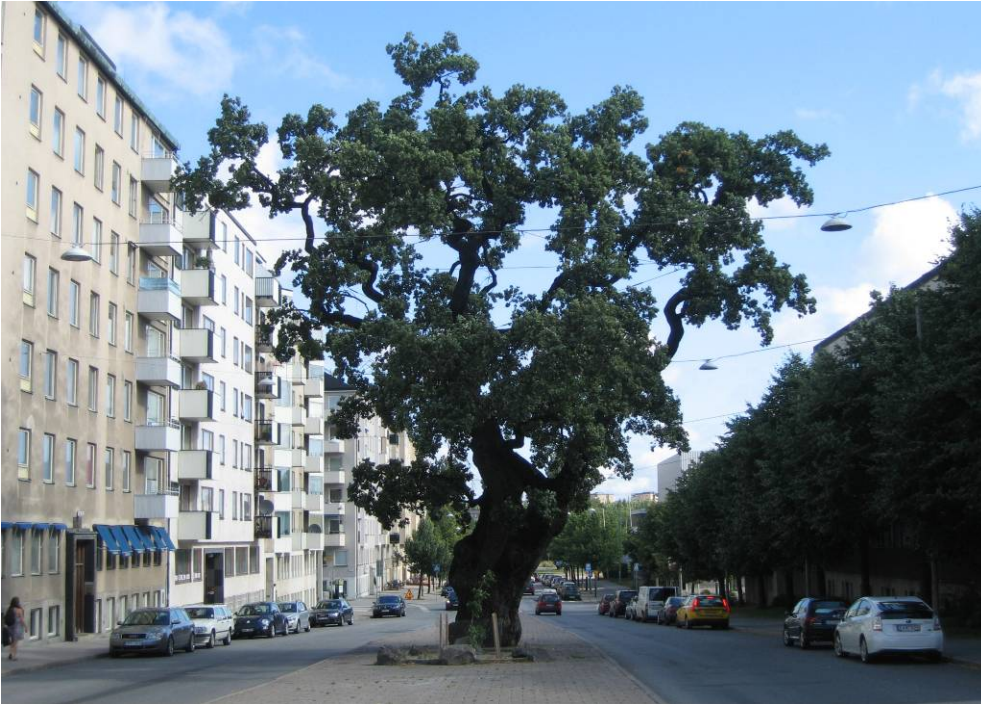
**2010 July:** Dense and dark green foliage gives the oak an appearance of good health and vitality when seen from this angle, but there is still twig dieback.

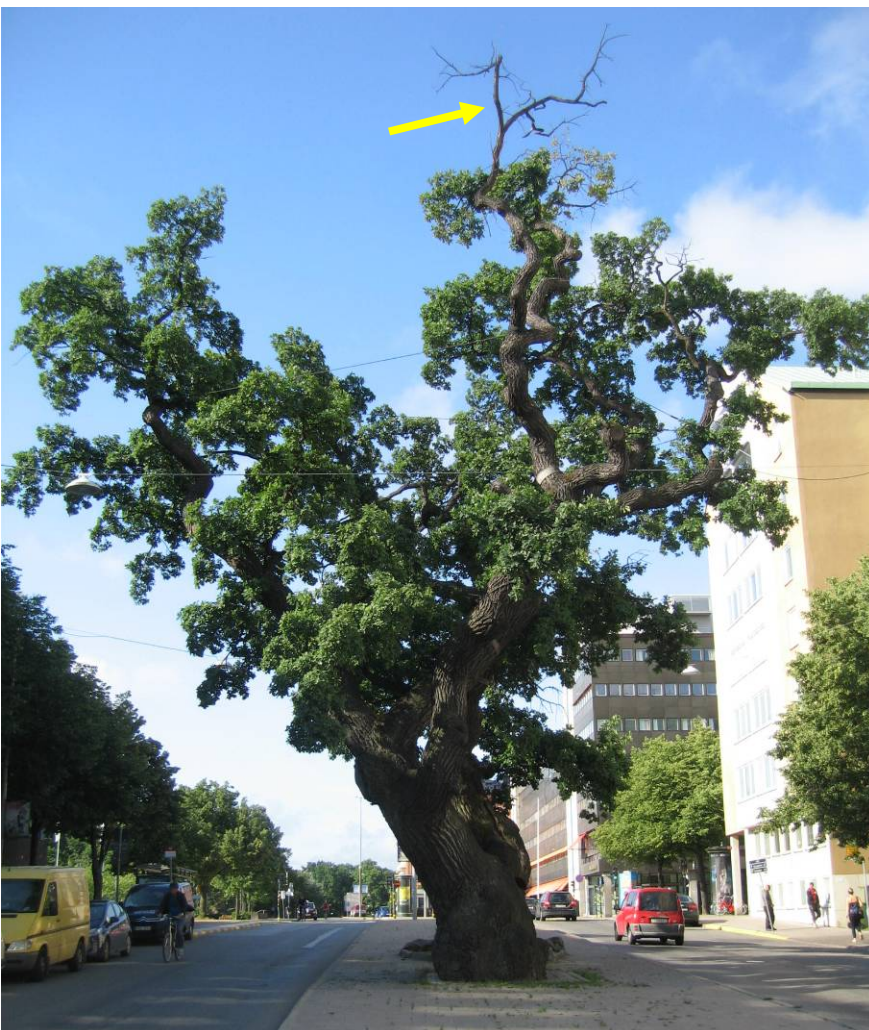
**2011 July:** One of the four remaining stems is dying, but the other stems have fairly good foliage in spite of scattered twig dieback. The overall size of the crown is smaller than in 2003, due to crown pruning, mainly of dead parts.

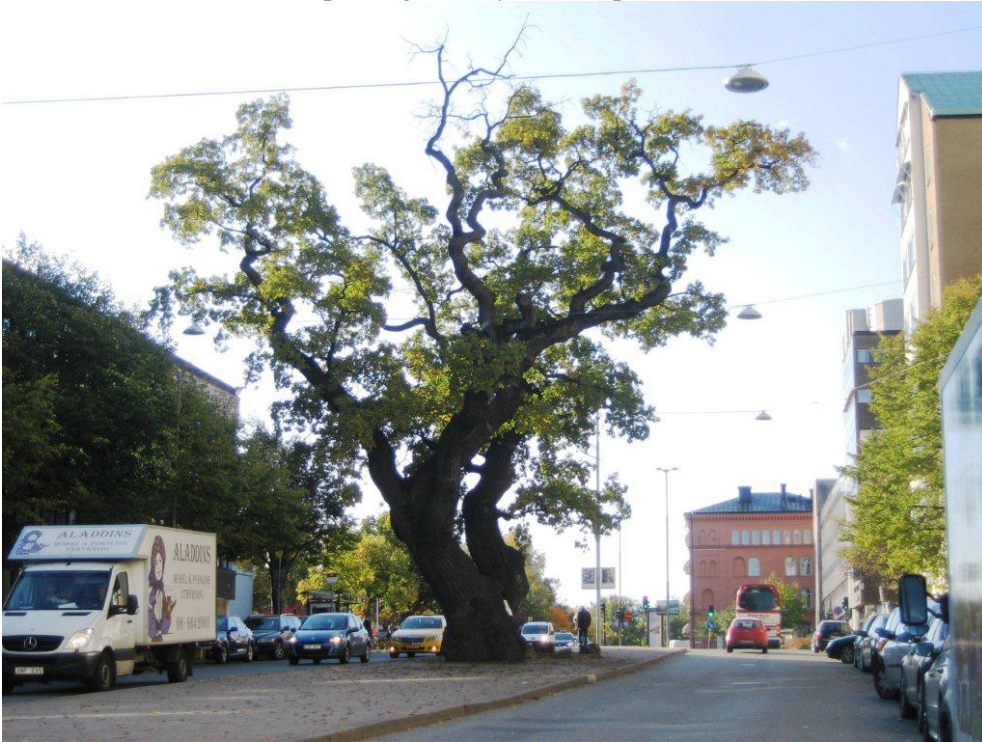
**2011 October:** Naturally the crown is expected to look thinner in autumn, but not before the leaves have turned brown. Compare with the crown density in October 2003. July-August 2003 were dry and warm, and although July 2011 was also dry in Stockholm, and the summer of 2011 was generally warm (according to smhi.se), August 2011 had plenty of rain. Overall tree vitality appears lower in October 2011 than in October 2003 even though weather conditions were less favourable in 2002-2003 compared to 2010-2011.

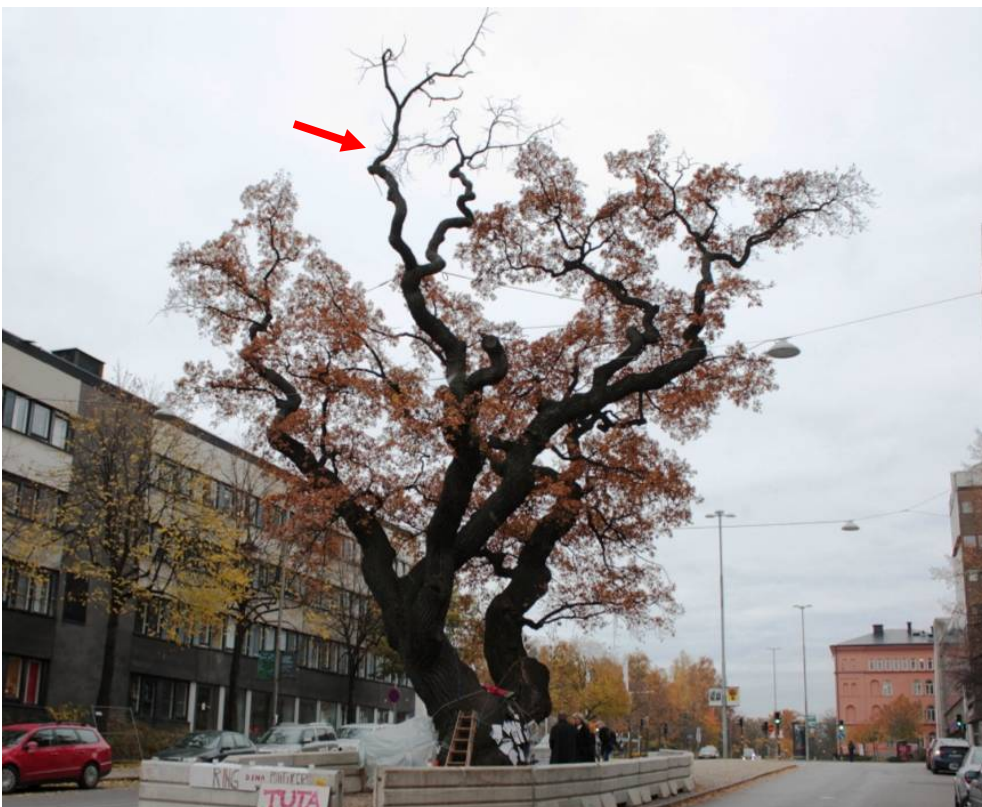
**2011 November:** By now autumn colour has appeared, the dead stem (which is situated directly above the large bark damage) stands out even more clearly.

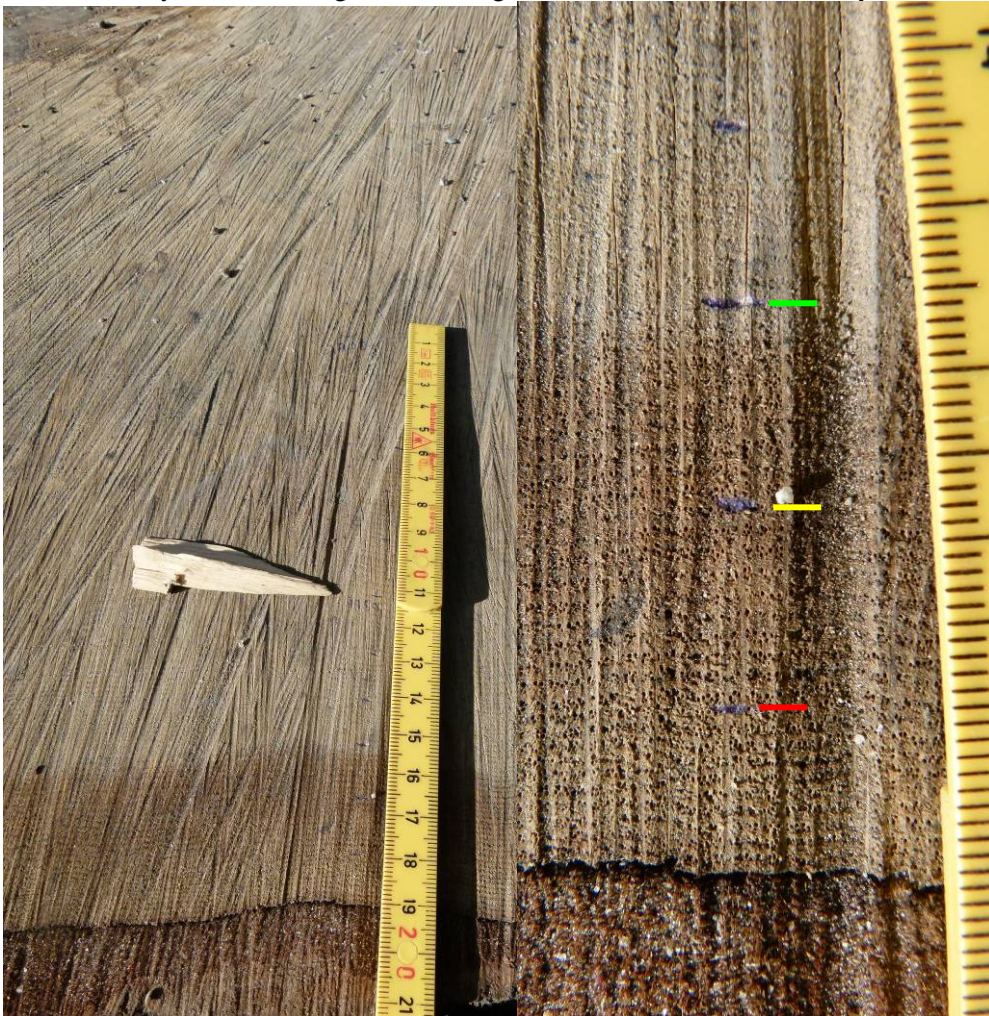
8. Looking at the year ring width for the past 111 years, it appears that the annual diameter growth dropped from the time of road construction. From 1900 to 1950 ten years of growth approximately equalled 45 mm of diameter growth (just over 2 mm wide year rings). But from 1950 to 2011 ten years of growth equalled a 26 mm of diameter growth (just over 1 mm year rings). Even so, an average annual year ring width of 1 mm is still quite respectable for an oak of 350-450 years.

Estimating growth for the past 111 years. The white arrow on the left point to the year 1950, and the end of the centimetre rule is at year 1900. Accuracy is probably  $\pm 3$  years. On the right, growth of recent years can be seen, and in most cases a year ring is about 1 mm wide. This is fairly good growth considering the age and condition of the oak. The red line is at year 2000, yellow line at 1990 and green line at year 1980. There seems to be a tendency to less growth in the years from 2000-2011 compared to the two earlier decades. The decrease is not in itself distinct enough to be proof of declining vigour of the oak, but it does fit the crown decline visible in the same period.

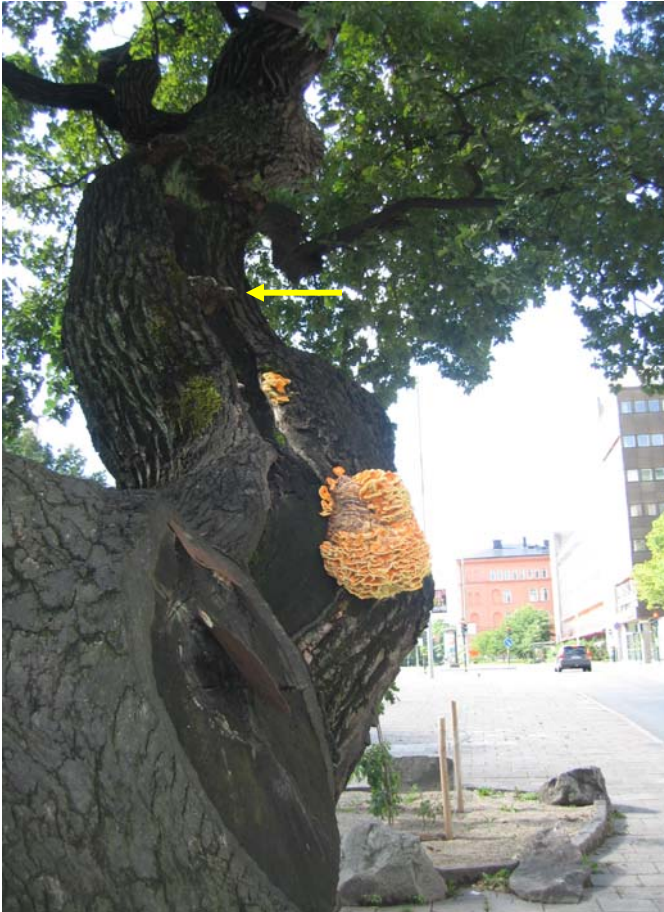
Sulphur polypore (*Laetiporus sulphureus*) on the stem with the large wound in 2010.

There are no earlier records of fruitbodies of *L. sulphureus*, but the fungus was present in the tree at the time the dead stem was removed in the late 1970'ies, because the metal plate on the pruning wound covered rot, next to which fruitbodies appeared in 2001 (below).

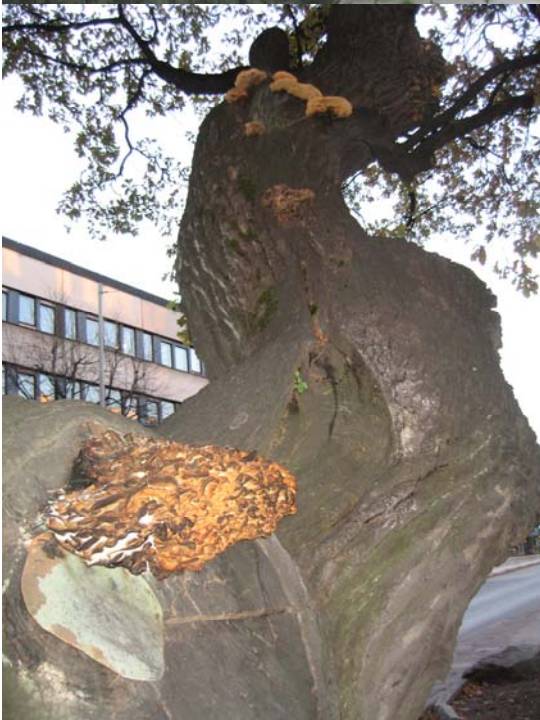
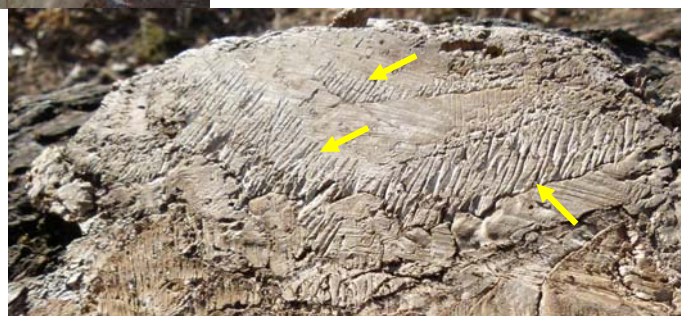
Sulphur polypore (*Laetiporus sulphureus*) fruitbodies on the large old pruning wound and oak mazegill (*Daedalea quercina*) on the stem with the large wound in 2011.

Actually, at least one old *D. quercina* fruitbody can be seen in the wound on the picture from 2010 (arrow above), so fruitbodies of this fungus must have been present since 2009 at least.

The identity of *D. quercina* was only certain after the felling, when the mazelike pore layer could be seen close up (arrows).

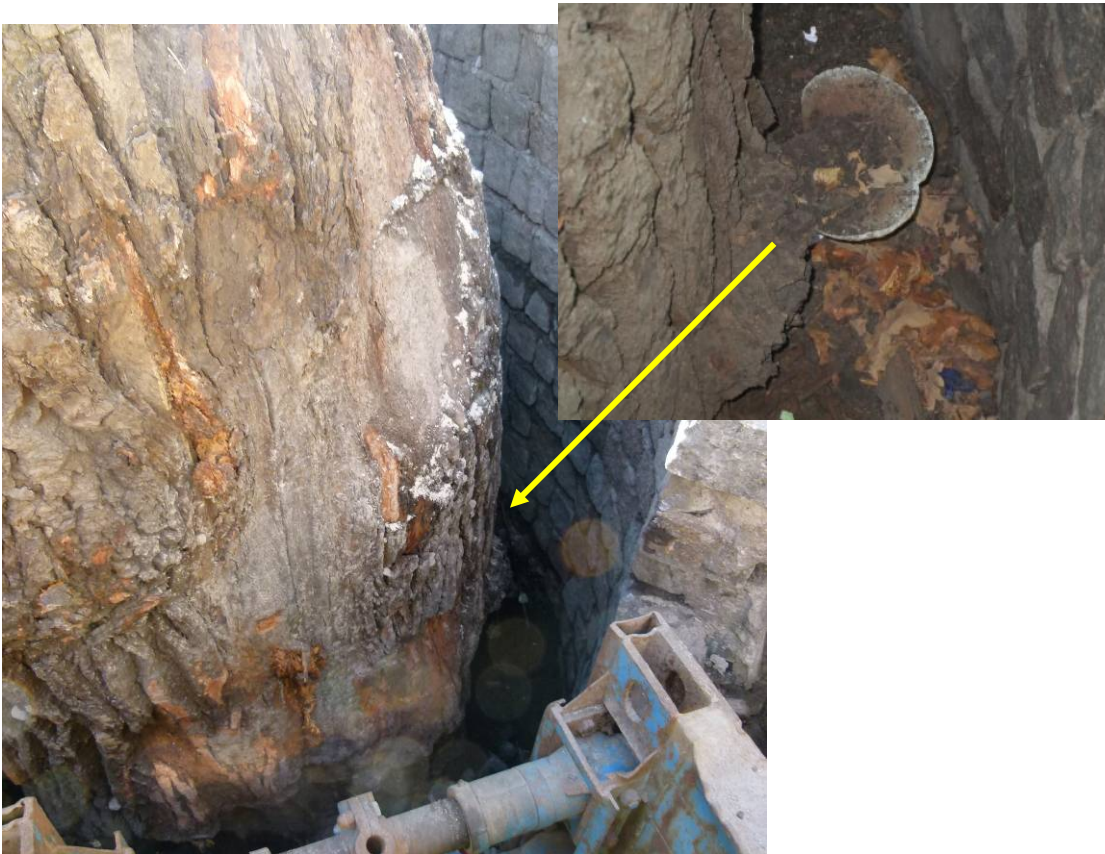
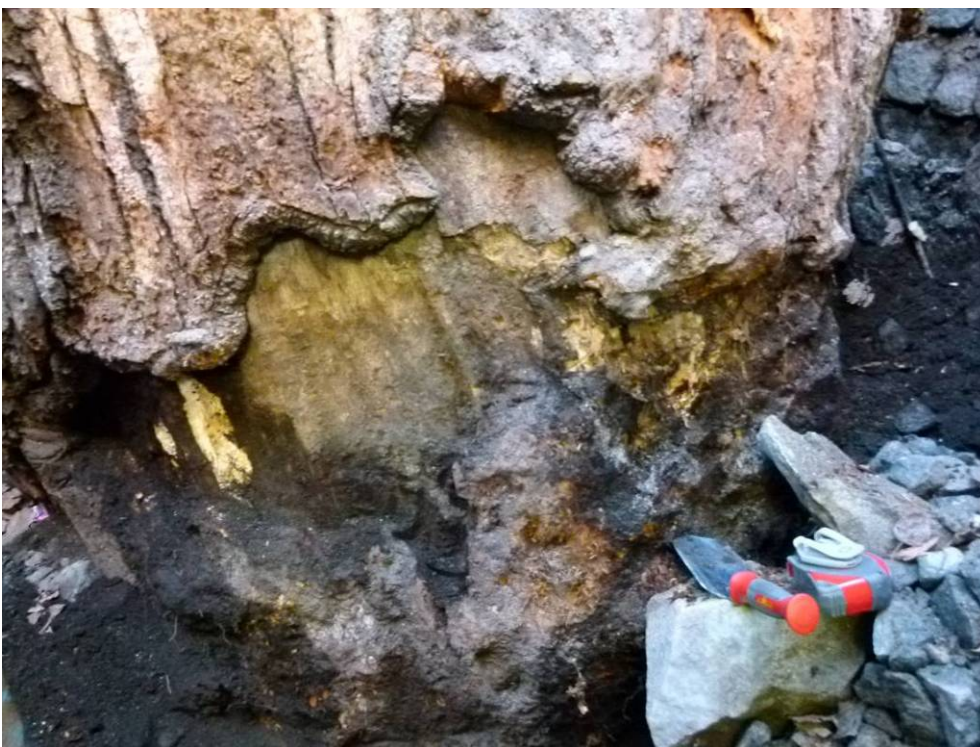
5. The main causes of the deteriorating health of the oak were severe damages to the root system (due to road construction in the 1950ies and 60ies). But also bark damage on one side of the stem at the bottom of the well built around the trunk. The latter injury remained undetected until the tree had been felled and partly excavated. The recently dead stem was directly above this bark damage.

Top: Looking into the well, which has been excavated on one side. Bottom: Large bark damage to the main stem, this damage probably dates from the time of construction of the deep well around the base of the tree. The precise time of wounding can only be determined by cutting the stump at this point and counting year rings, but apparently there has not been any work done in the well after construction. The well was almost 5 meters deep, where the excavation stopped and there were still no signs of the roots. Fruitbodies of beef steak fungus (*Fistulina hepatica*) was found to the right of this wound (arrow).

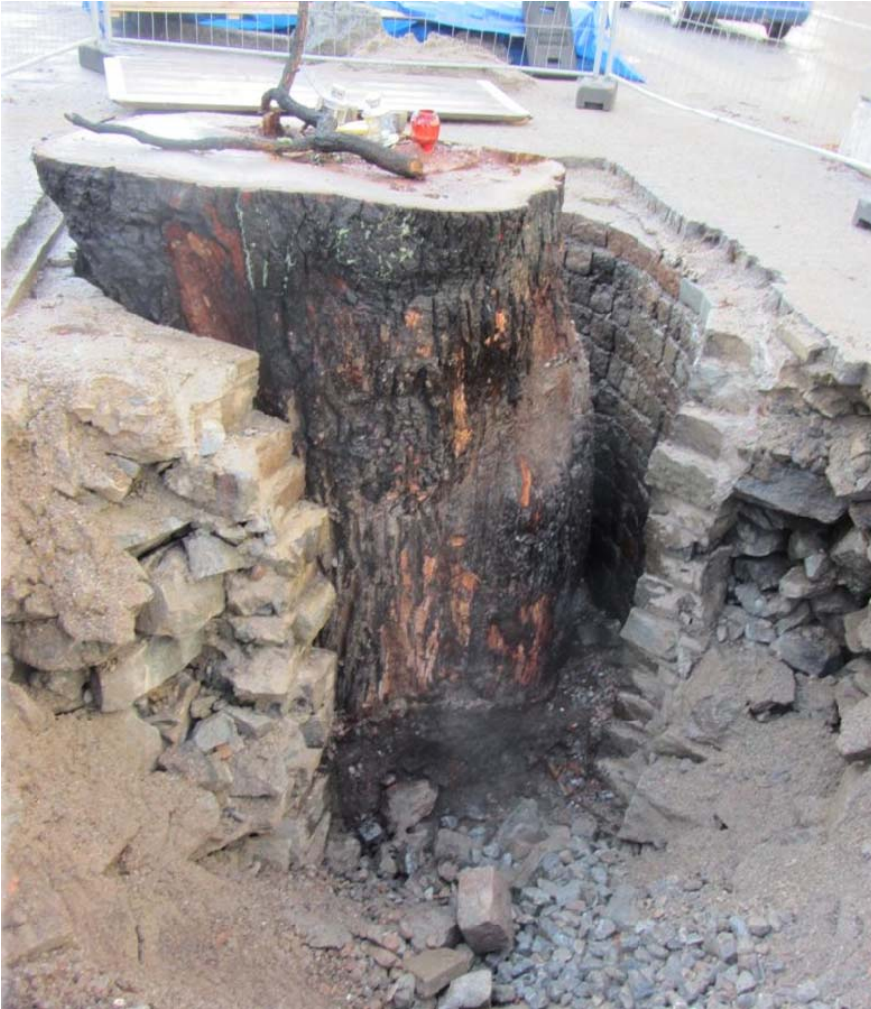
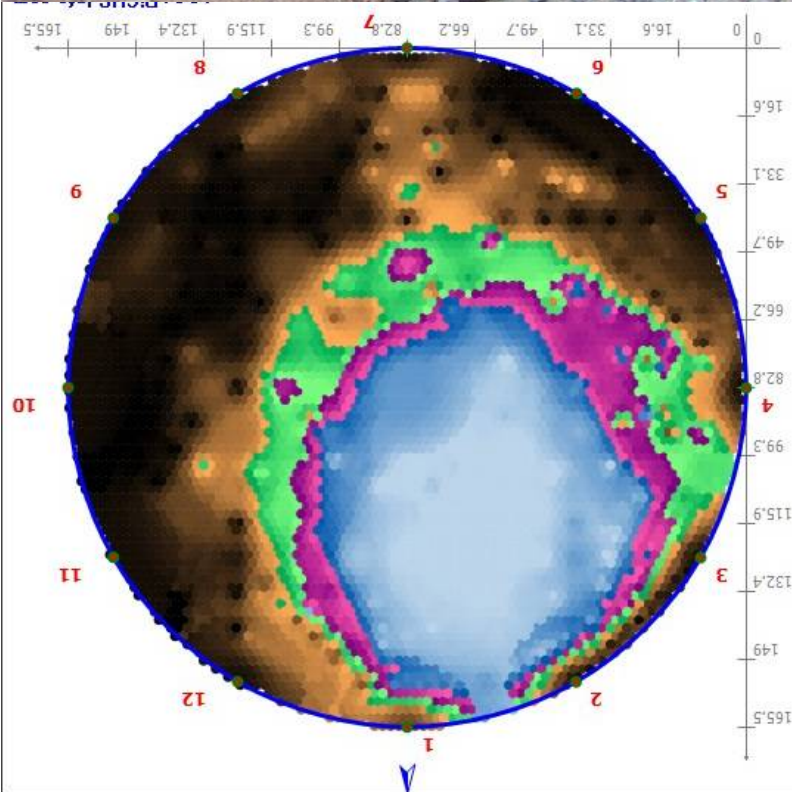
4. The risk of failure of the main stem or the root system existed, but it was not yet imminent. However, according to rot measurement at the underground base of the stem, done after felling and excavation around the stem, the decay

near the roots was extensive and more advanced than might have been expected from the fungus present (beef steak fungus, *Fistulina hepatica*).

Rot measurement at the base of the main stem in 2011 at the bottom of the excavation. No 1 is towards north and approximately in the middle of the large wound. The rot here is probably mainly due to *F. hepatica*, but *L. sulphureus* could also be involved. The amount of rot is surprisingly large and advanced (blue area).

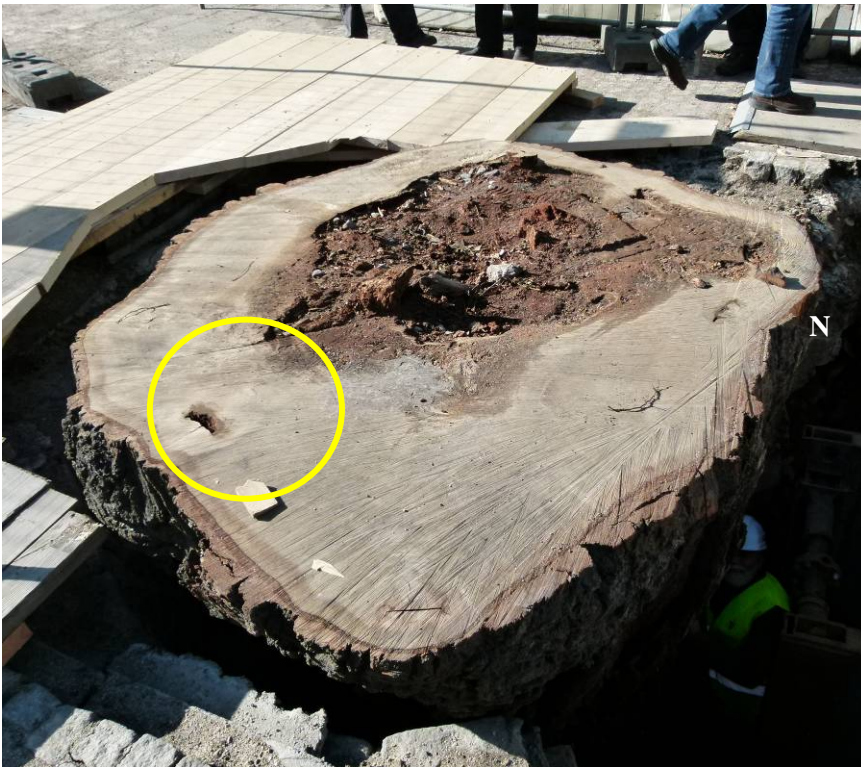
Actual decay inside the main stem in 2011, this corresponds fairly well to the earlier rot measurement shown below, although there is less rot in the area marked by a yellow circle than estimated in the computer image. Both computer image and photo are seen from the same direction (from above), so the result can be compared directly.

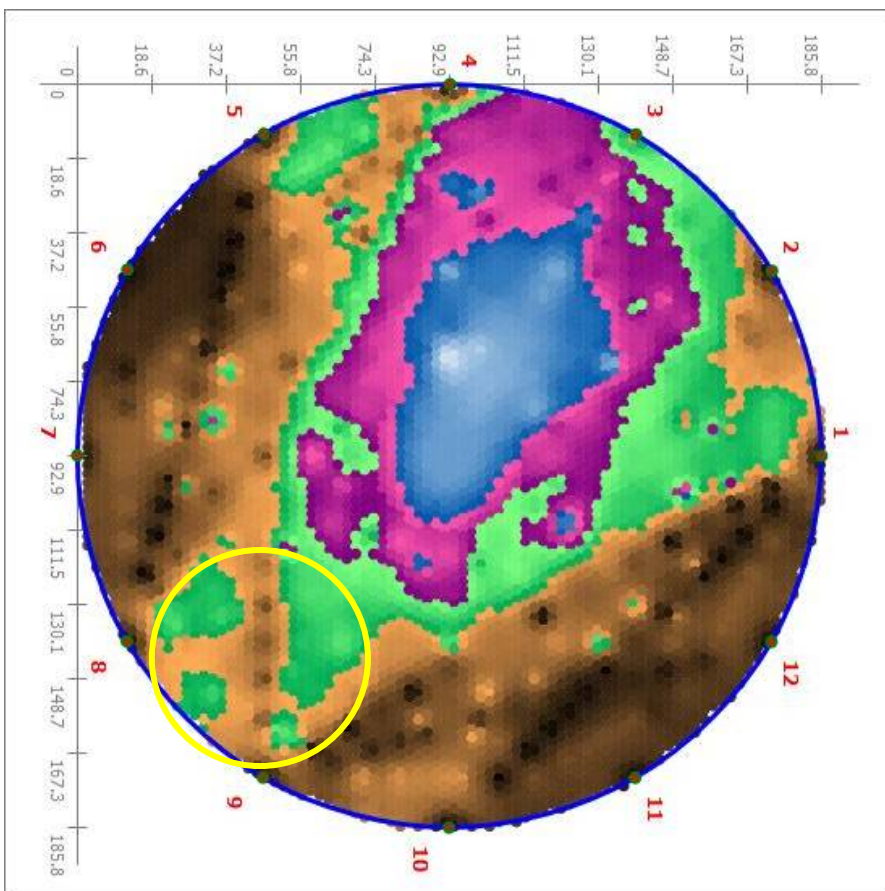
Rot measurement of the main stem in 2003, just above the wood deck. 1 is usually set towards north. The rot shown by purple and blue is quite accurate compared to actual rot extent in 2011 (as seen above after felling).

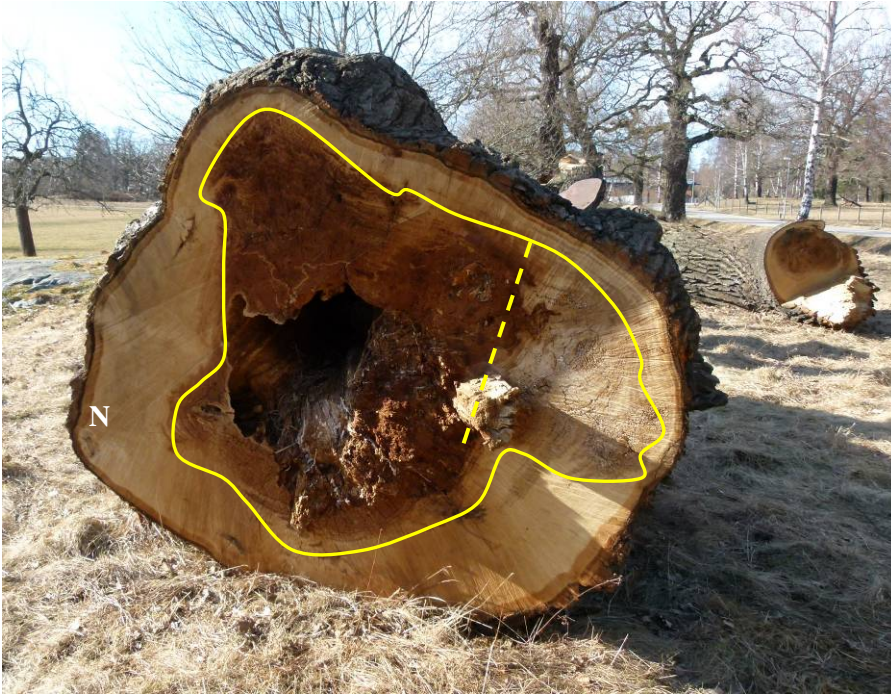
Main stem cross section just below the division point at 2,5 meters during inspection of remains in March 2012. The extent of decay is quite clear (demarcated by yellow line). The dotted line is the border between two overlapping decay columns, the central dark brown rot caused by sulphur polypore (*Laetiporus sulphureus*), whereas the lighter brown rot to the right is most likely oak mazegill (*Daedalea quercina*).

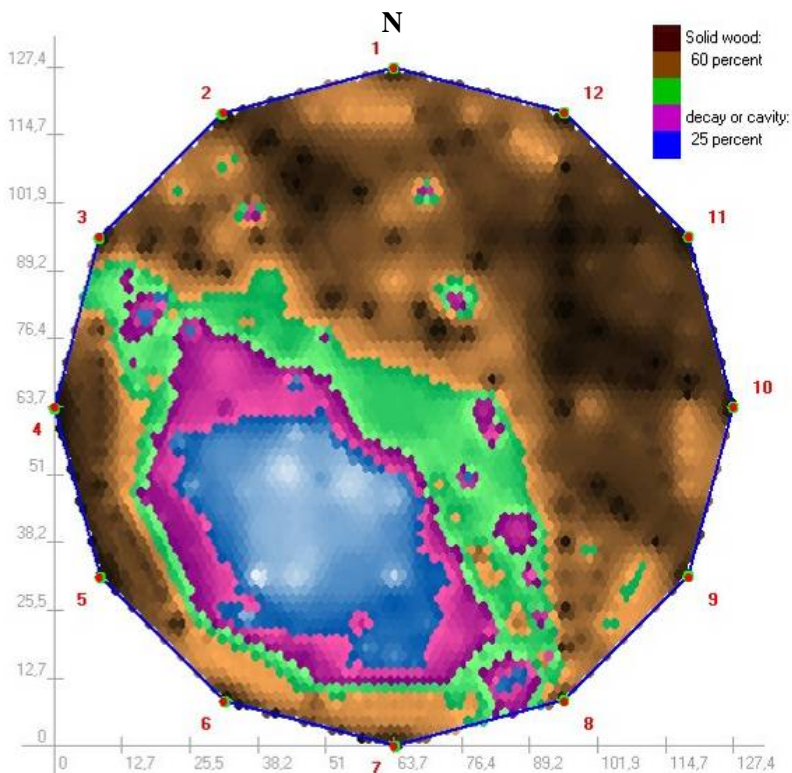
Compare with rot measurements from 2007, taken 180 cm above the wood deck, it is clear that the extent and severity of decay in the upper part of the main stem was fairly accurately estimated. North is marked on both images, the photo is seen from below, but the computer image is from above. This makes direct comparison slightly difficult, but the main abnormal area (blue) in the computer image corresponds to the upper half of the decay in the photo.

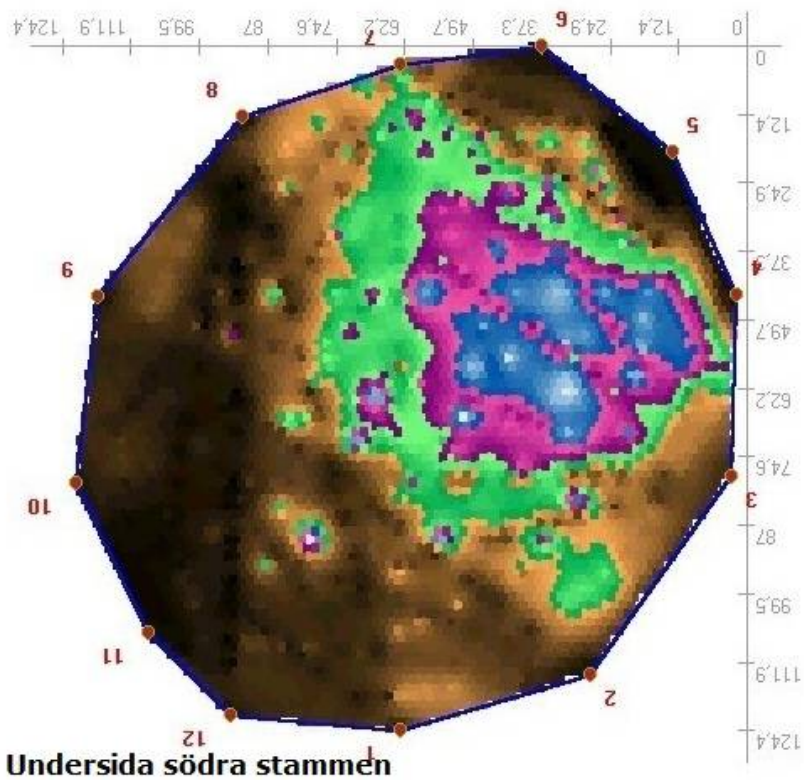
Rot measurement of the south stem in 2003, this is the stem with a long open wound. The upper part of the stem is decayed, compare with actual rot in 2011, see below.

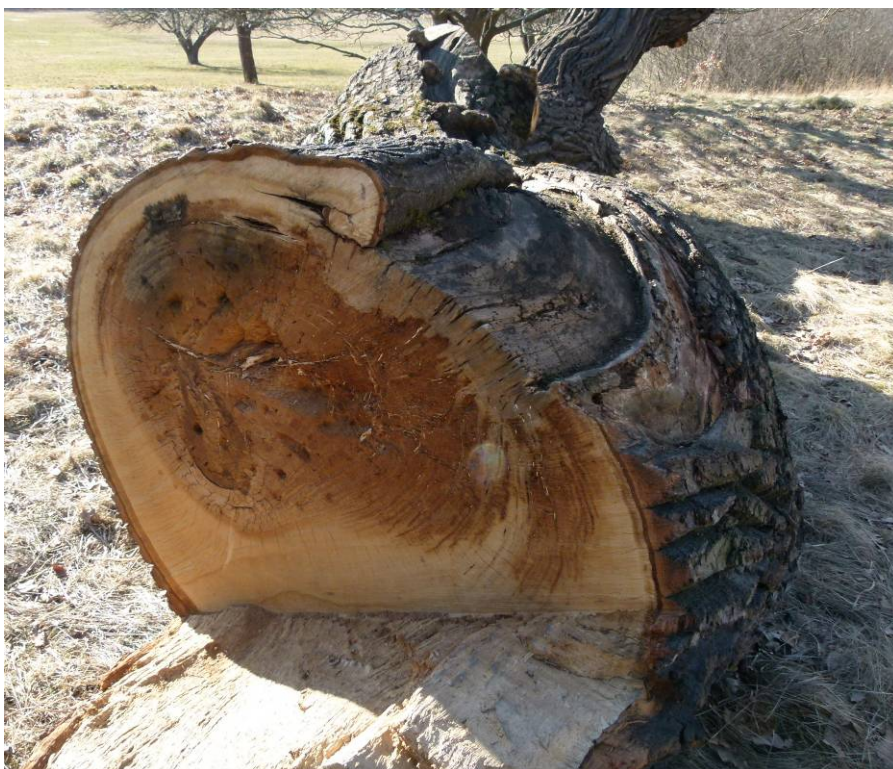
Actual decay inside the south stem in 2011, this corresponds fairly well to the earlier rot measurement, but the amount of decay in the heart wood has increased as may be expected. Note that the main (brown) part of the rot is probably mostly due to sulphur polypore (*Laetiporus sulphureus*), whereas the lighter (grey brown) rot just below the wound surface is caused by oak mazegill (*Daedalea quercina*).

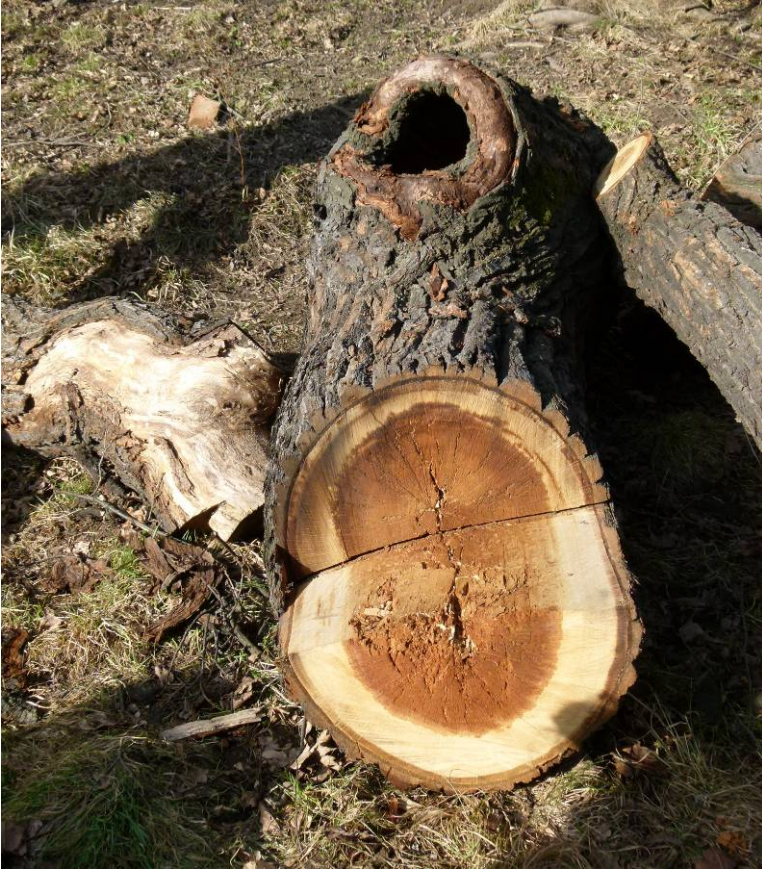
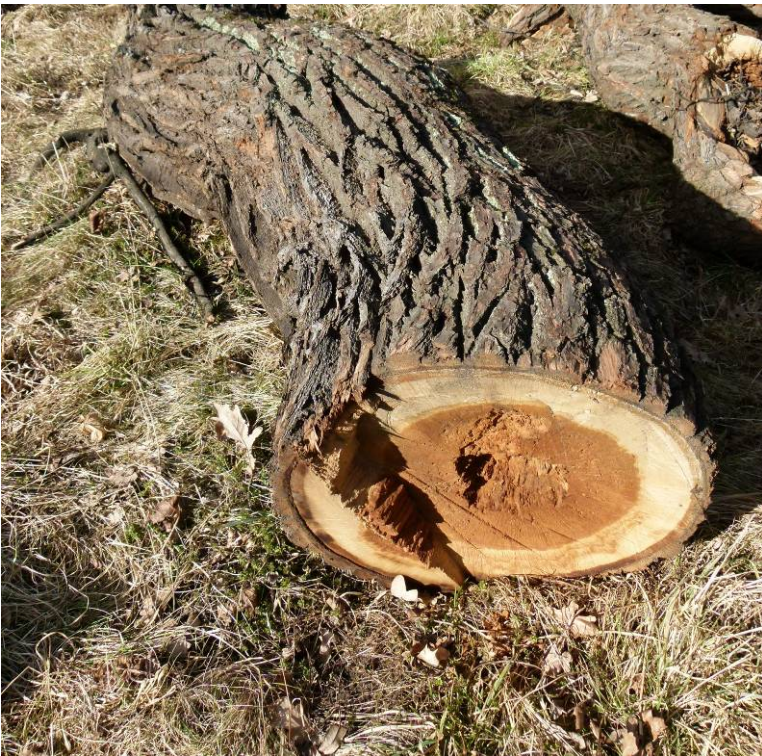
Examples of central heartwood decay in upper stems, the old open wound on the top picture could very well be the original entry point for sulphur polypore (*Laetiporus sulphureus*), as the decay is typical for this fungus.
